# STEEL VS. PVC: LOCATING POTENTIAL FRICTION FAILURES

Jess Campbell, Jeremiah Davis, John Linhoss, Kelly Griggs, Cody Smith, Cason Edge and Martha Rueda  
National Poultry Technology Center – Auburn University College of Agriculture – September/October 2021

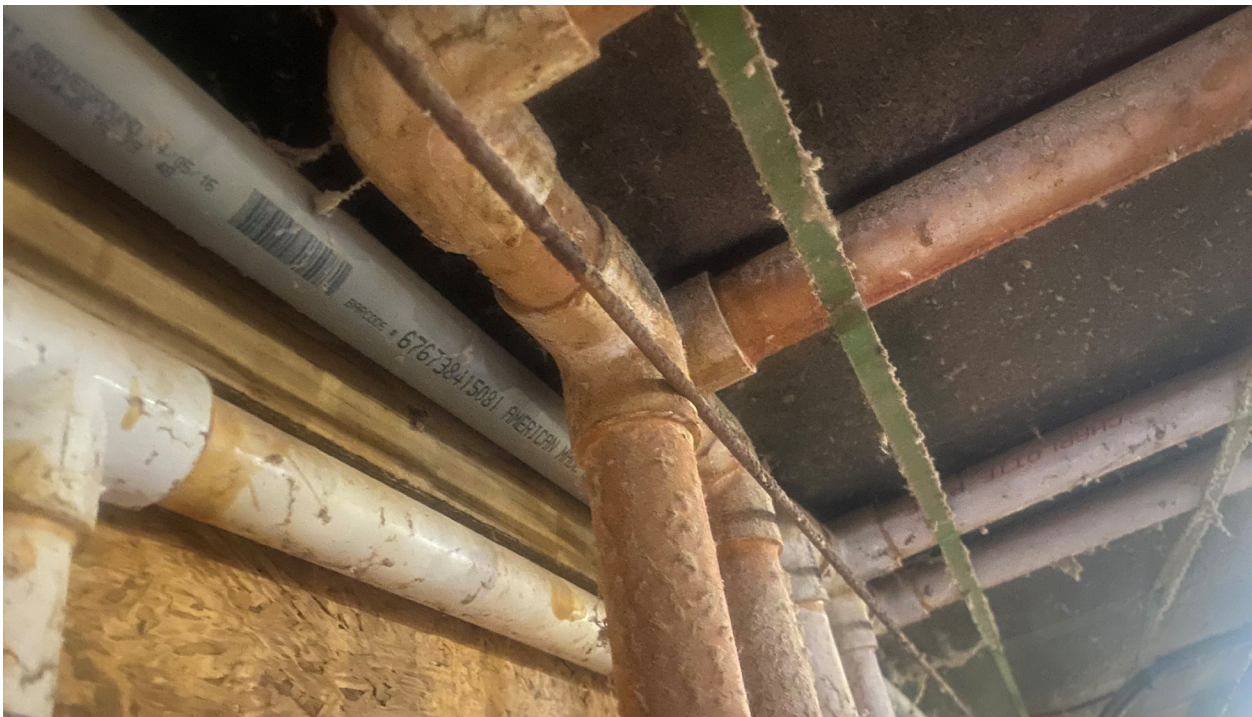
*Photo 1: Can you spot the potential friction failure here? This is a picture of the continuous steel rod that connects the vent doors together. This steel rod is rubbing against a 3/4-inch SCH 40 PVC water supply line to the drinkers. It is just a matter of time before this rod rubs through the 90-degree coupling and line and causes a major leak in the middle of the house inside from the control room. This problem must be corrected immediately.*

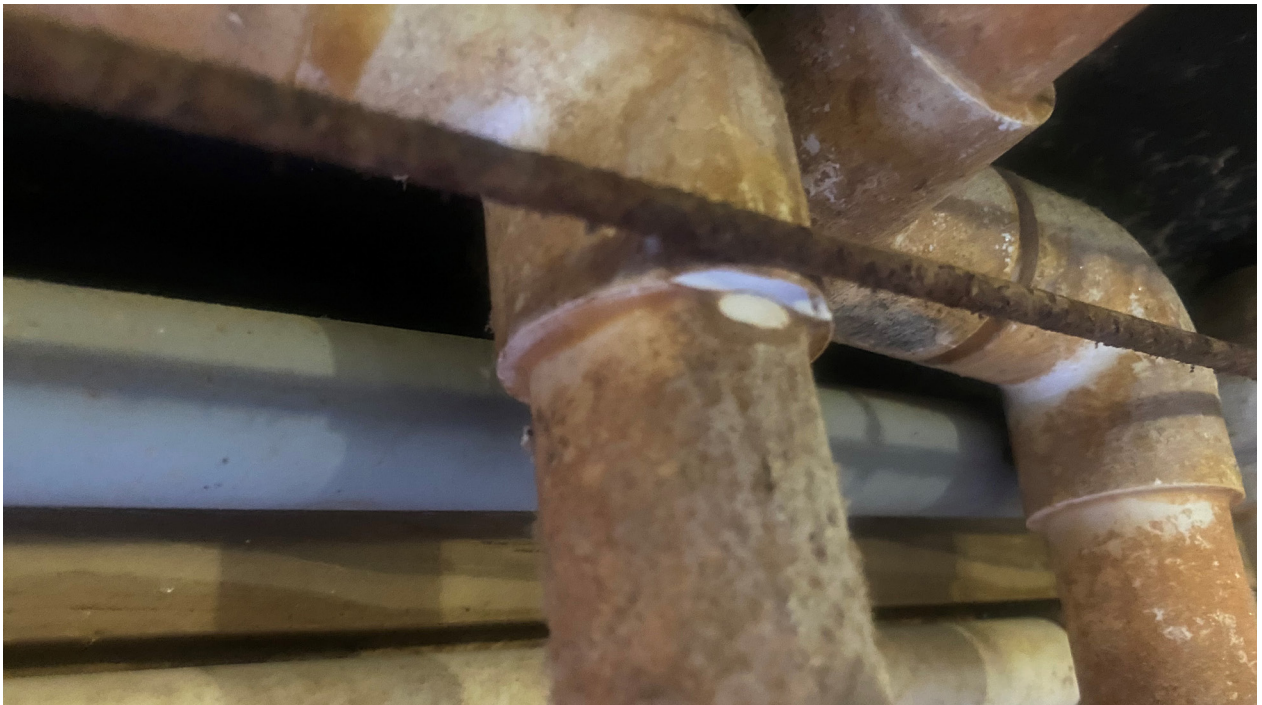
*Photo 2: This is a similar picture showing the continuous steel rod rubbing directly into the 3/4-inch SCH 40 PVC water supply line in another house. Again, this is just a disaster waiting to happen and must be corrected ASAP.*

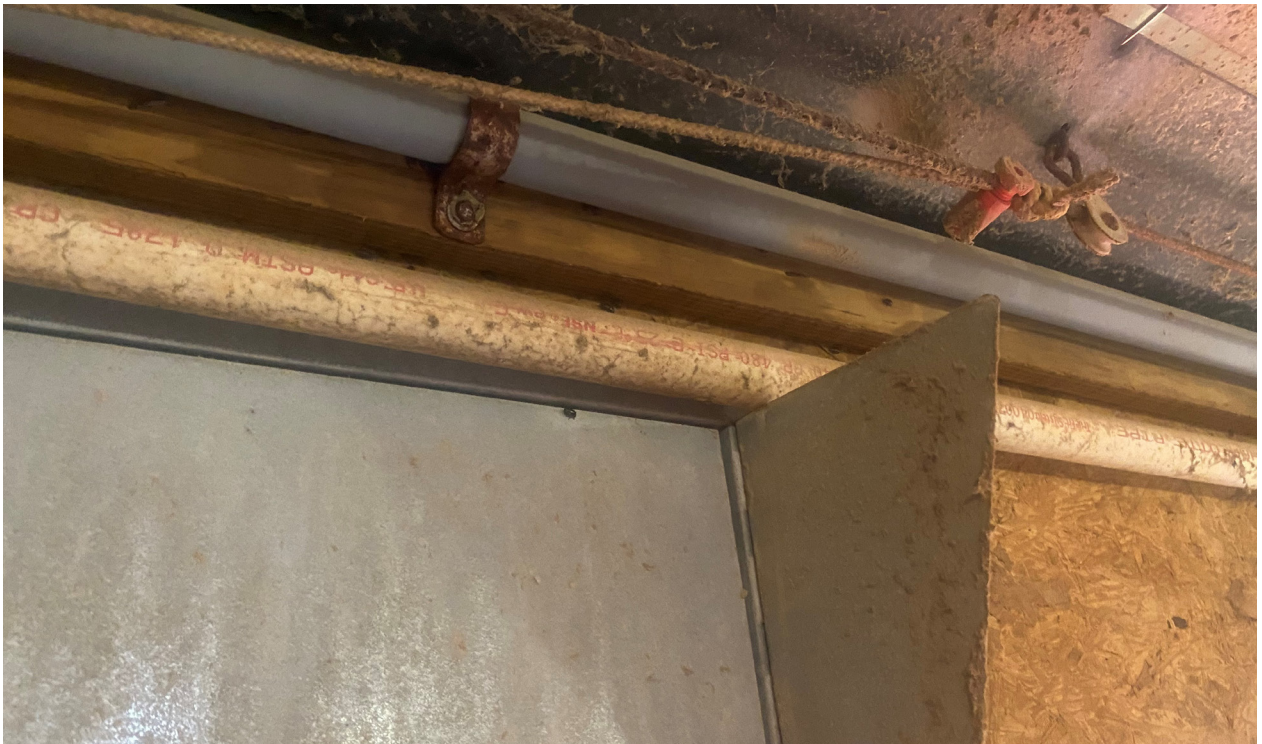
*Photo 3: Can you spot this potential friction failure? This is not an example of a moving steel rod, cable or rope. Gravity and friction play a leading role in how this scenario will play out. Regardless, it is just a matter of time before this metal vent shield rubs a hole into this PVC water line and causes major problems inside the poultry house. Again, the goal is to prevent the potential for any and all friction failures from causing problems.*
